# Home Inspection Report

of  
326 W. Main St.  
Sample IL.

for  
Mr. and Mrs. Homebuyer  
on  
Monday, January 1st.

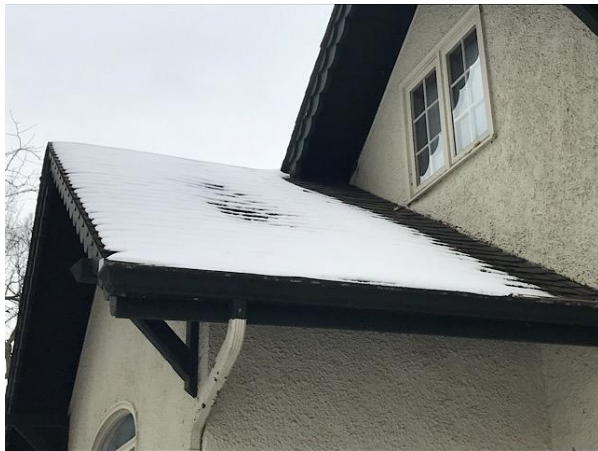
Snow covered roof

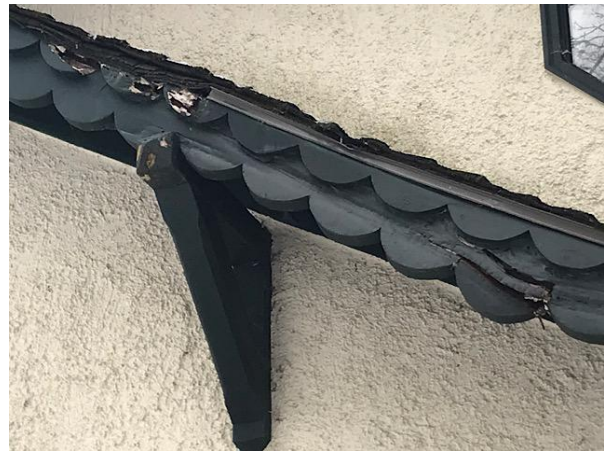
- c. The 2021 Lennox furnace located in the basement is dirty with seasonal dust and the humidifier is dismantled and damaged..
2. **ROOF:** There appears to be several layers of shingles on the roof. The shingles are damaged above the rotted fascia boards at the front of the home. There is moss growth in areas. There are no crickets above the east or west brick chimneys. Portions of the roof were not visible due to snow cover. Water stains and small areas of blackened sheathing are visible in the attic.  
The garage flat roof below the deck was not visible. However, there is an active leak from the roof onto the garage ceiling as confirmed with thermal imaging and there are water stains on the laminated beams and rim joist inside the garage below the rooftop deck. \*\*\*I recommend a professional roofer evaluate for life expectancy and cost of repair prior to closing.

Multiple layers of shingles. Damaged tabs. Rotted fascia boards

Remarks:	I recommend the roof be professionally evaluated prior to closing due to the visual condition or the fact that it could not be fully viewed.	A professional roofer should determine the amount of life remaining in this roof and the cost of replacement.
----------	--	---

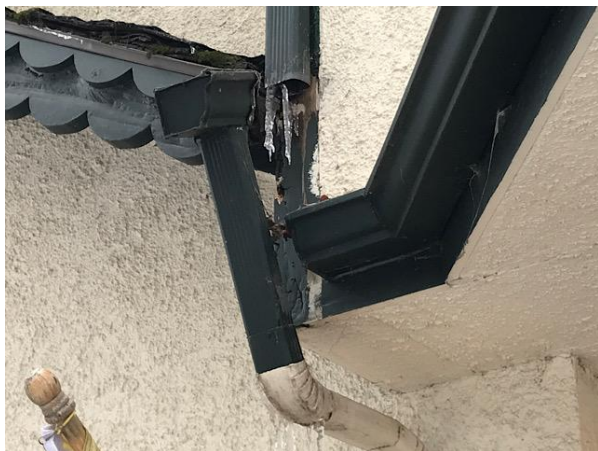
- A. Note: Portions of the roof and grounds were not fully visible due to snow cover.
- B. The front downspout and small piece of gutter are loose and separated from the wall. Water will be deposited next to the foundation wall. Proper exterior water management is critical in preventing seepage.

Loose front gutter and downspout

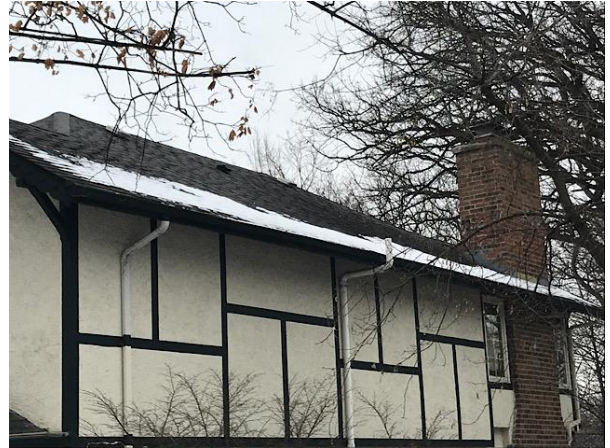
Moss growth on shingles

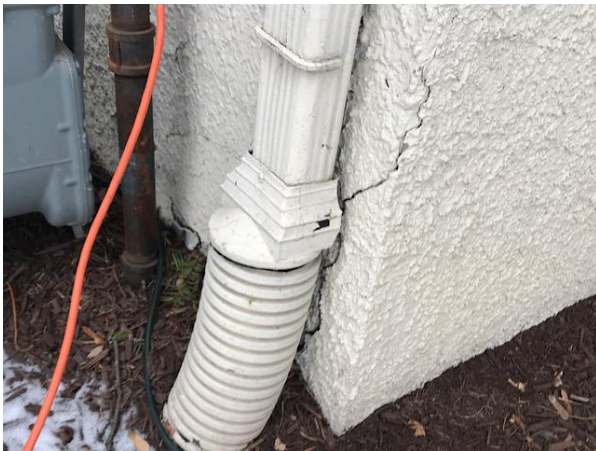
Example of cracks in stucco siding

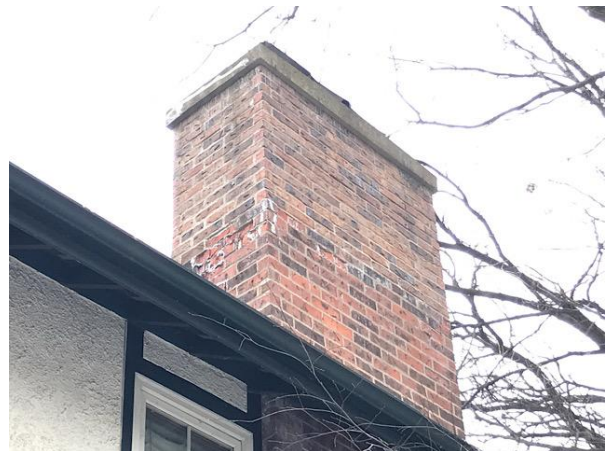
- F. The concrete side walkway is cracked and settled.
- G. The west brick chimney has spalled bricks and loose mortar joints above the roof line. The chimney cap is cracked. No cricket flashing is visible.

Spalled bricks & cracked cap

Chimney Remarks: Chimney bricks need tuck-pointing and general repair Multiple Issues  
The damaged chimney cap should be repaired

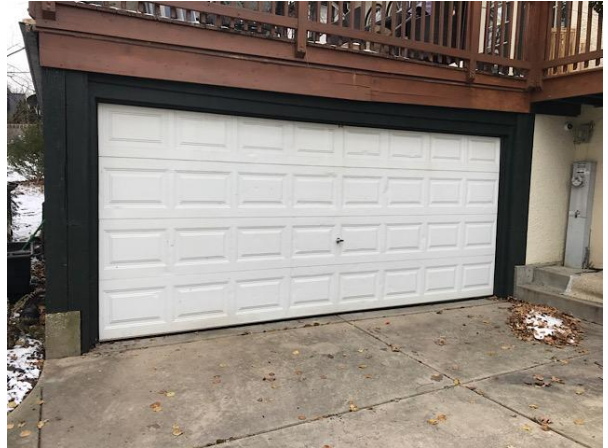
Dented garage door

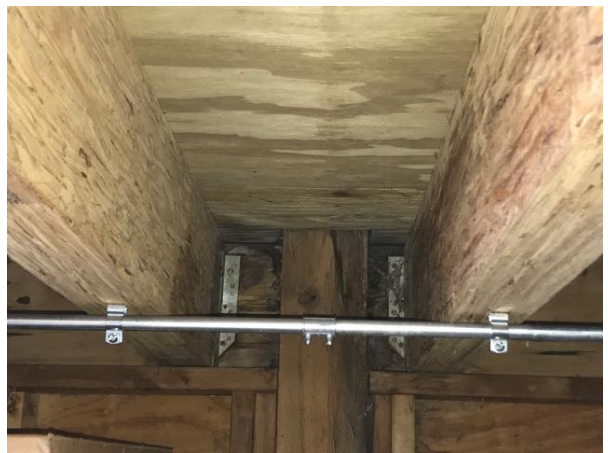
- N. There are water stains on the laminated beams and rim joist inside the garage below the rooftop deck and garage roof.

Water stains inside garage, below the roof deck

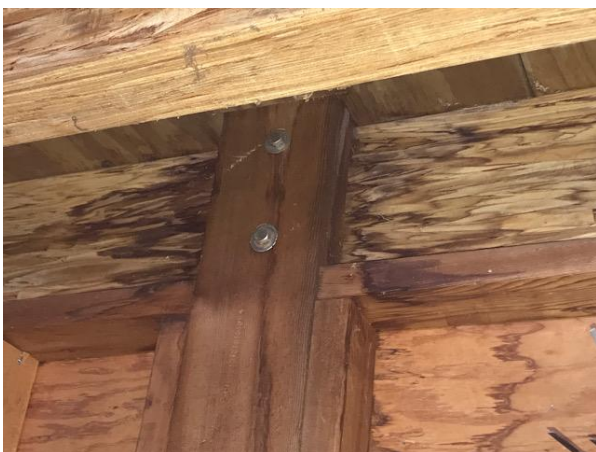
Water stains inside garage

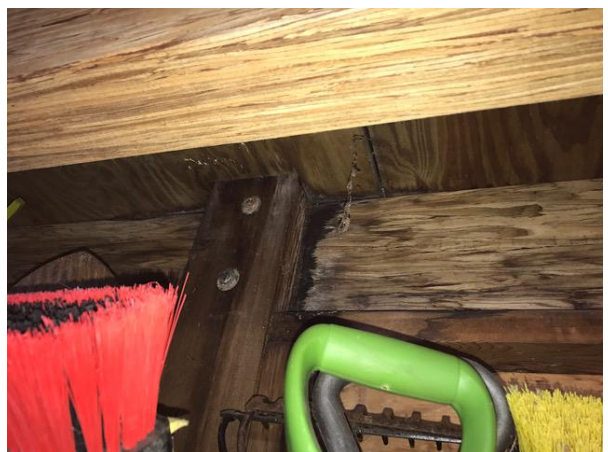
Water stains inside garage

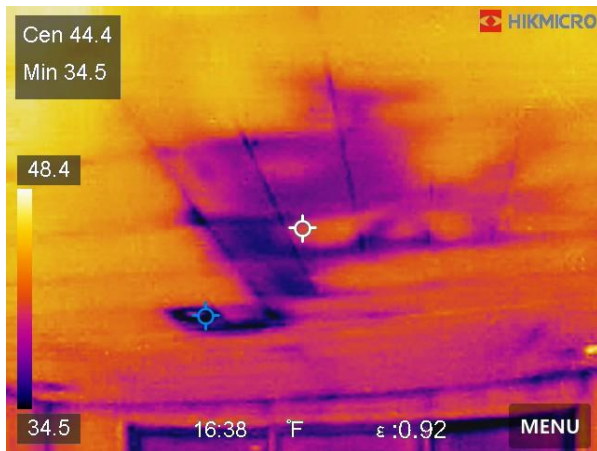
Thermal image confirming garage roof leak

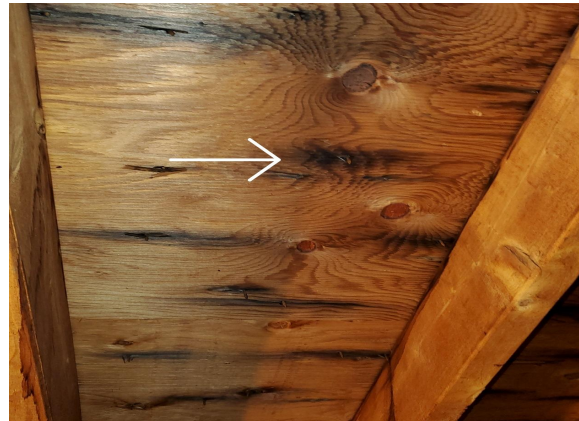
Darkened sheathing

Remarks: See Pictures  
Blackened moist or frosted sheathing indicates a possible ventilation/insulation issue and should be professionally addressed.

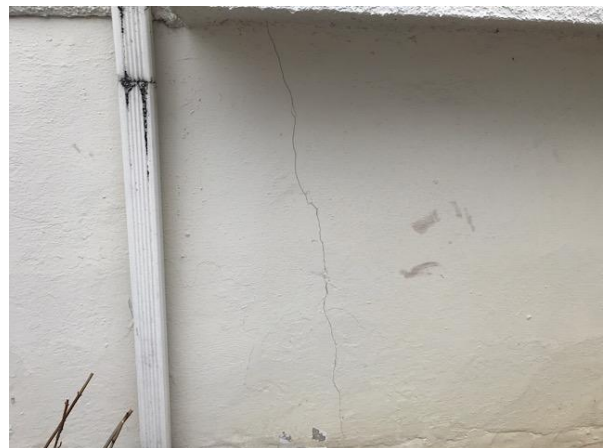
Cracks in foundation walls visible from the exterior

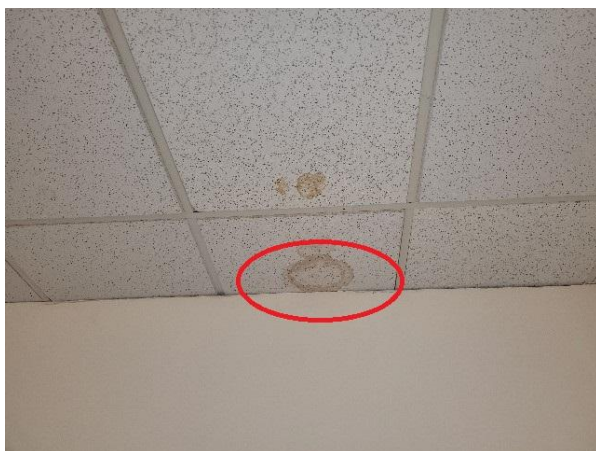
Active water leak in basement family room

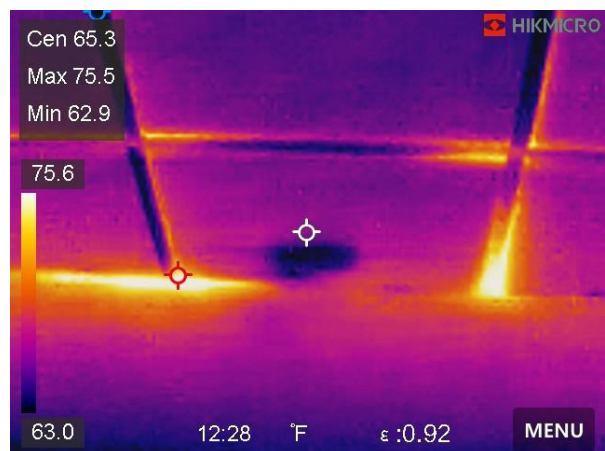
Thermal imaging confirming leak is active

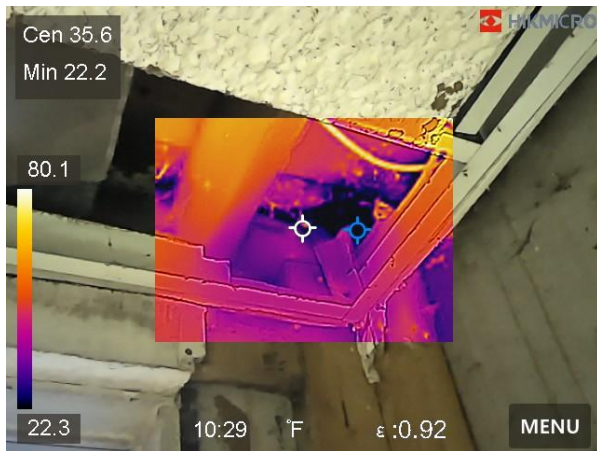
Precise location of active water leak

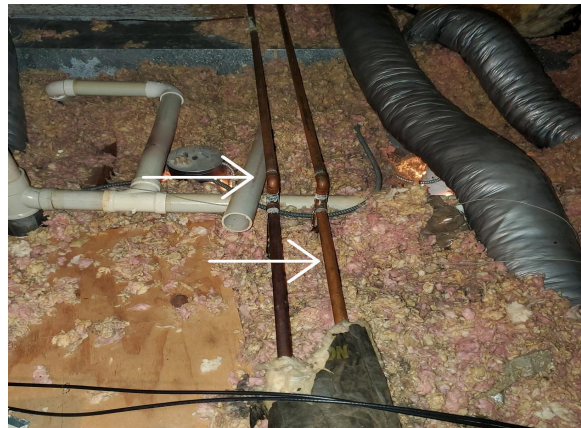
Exposed active water lines in attic

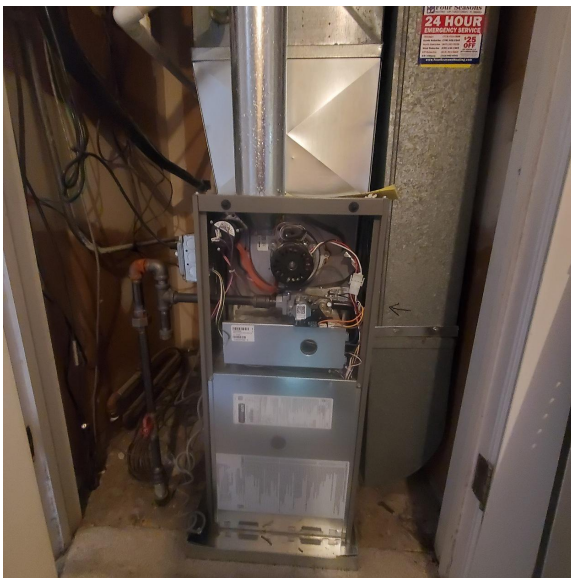
Lennox furnace seasonal dust

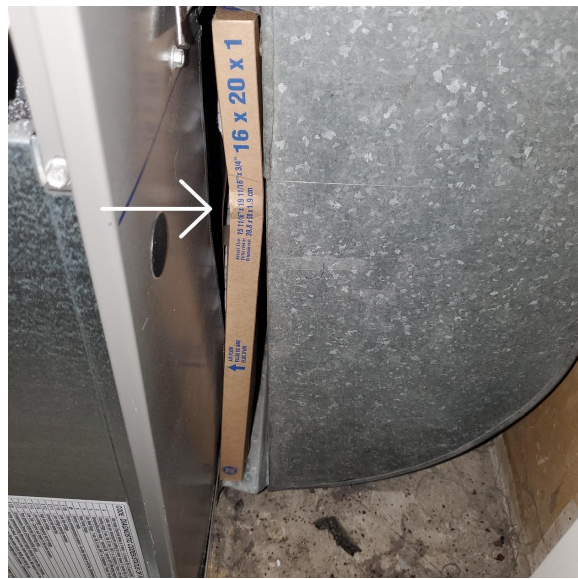
Unsealed furnace filter opening

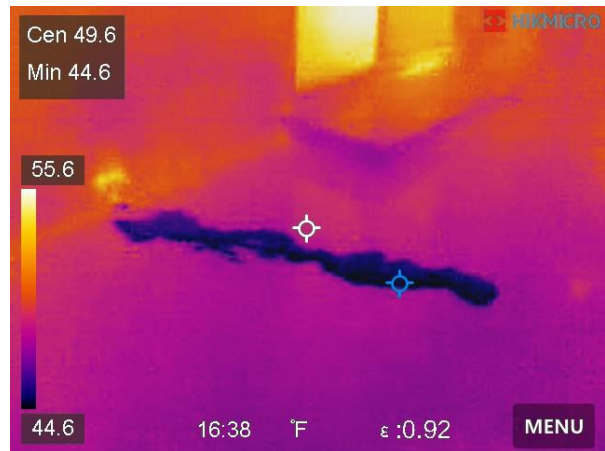
Thermal image of leaking faucet onto rug

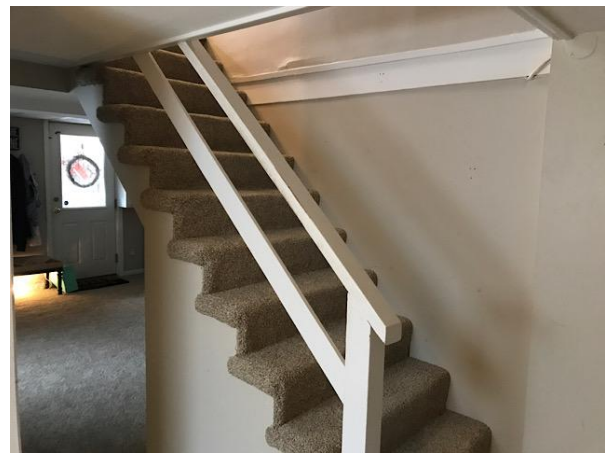
Unsafe balusters

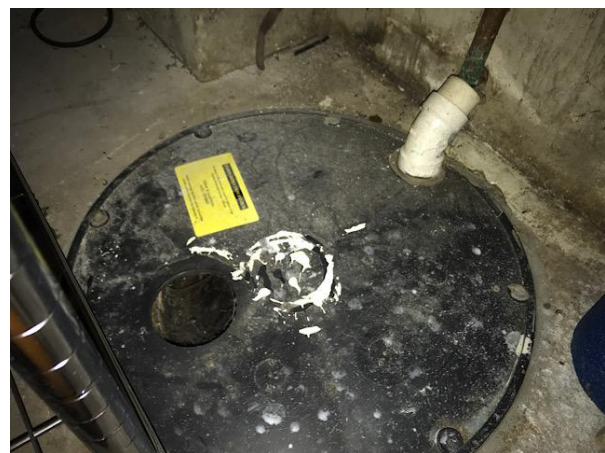
Sump pit is not sealed for Radon

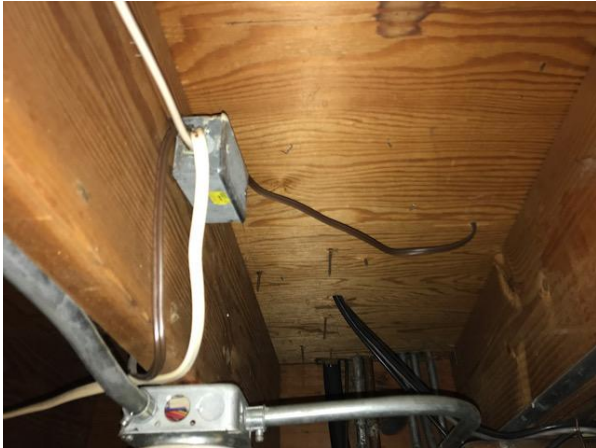
Brown, lightweight, lamp cord wires improperly routed through the floor

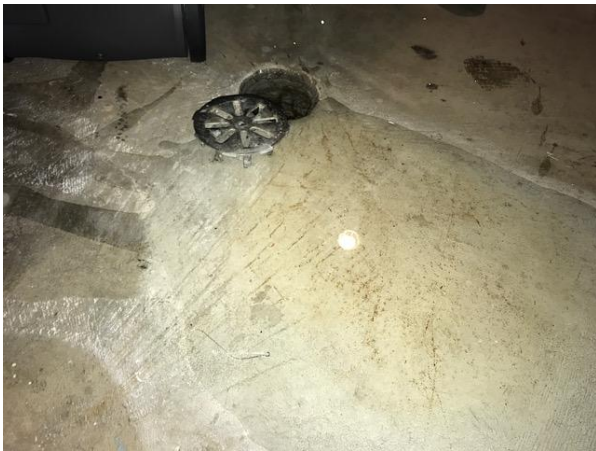
Utility sink water backing up through the floor drain

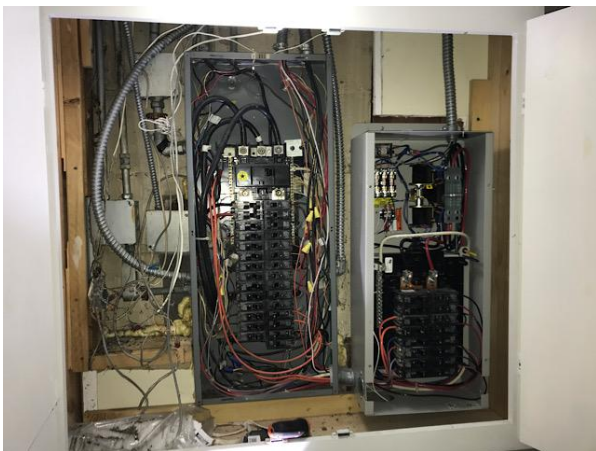
Fabric covered aluminum wires present on main panel circuits 2 & 9.

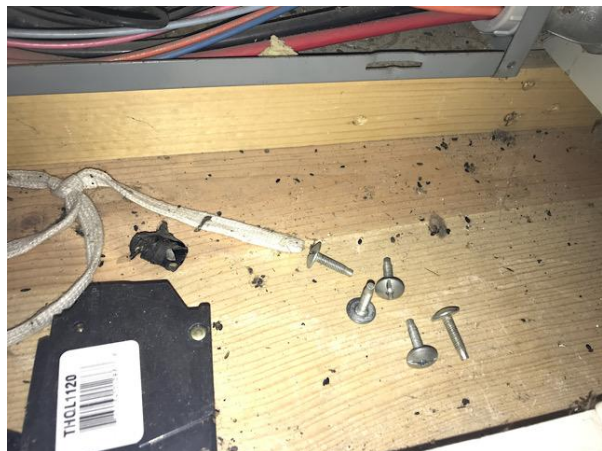
Rodent droppings present below the electric panels

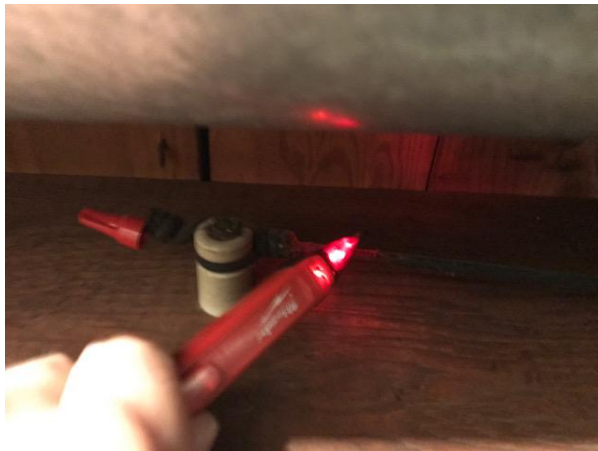
Live knob and tube wire present in the basement and east crawl space

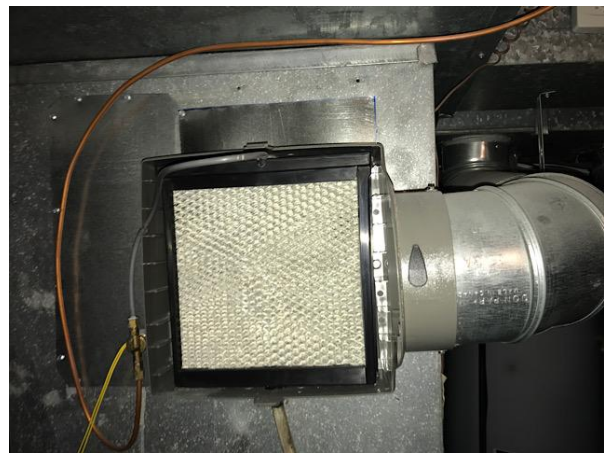
Humidifier is damaged and dismantled

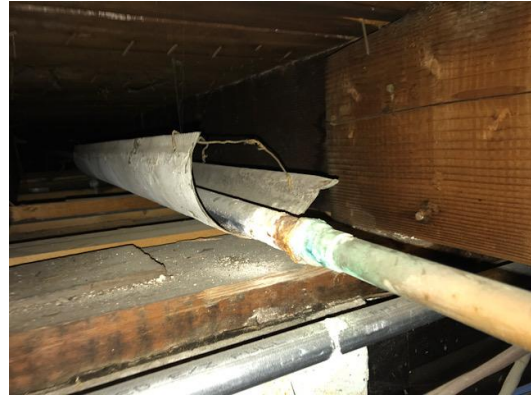
Rusted / Corroded copper to galvanized pipe unions. Missing several dielectric connectors

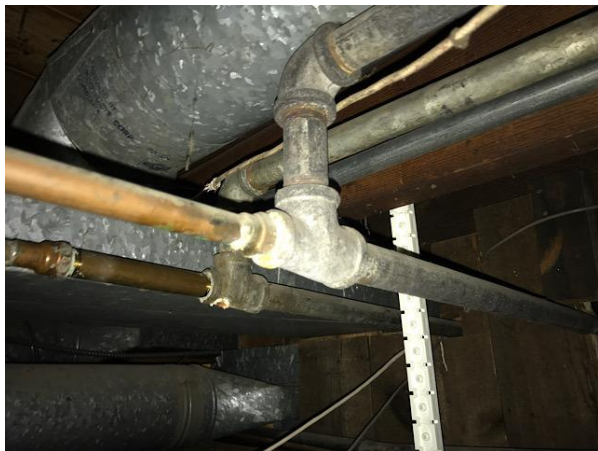
corrosion: missing dielectric union

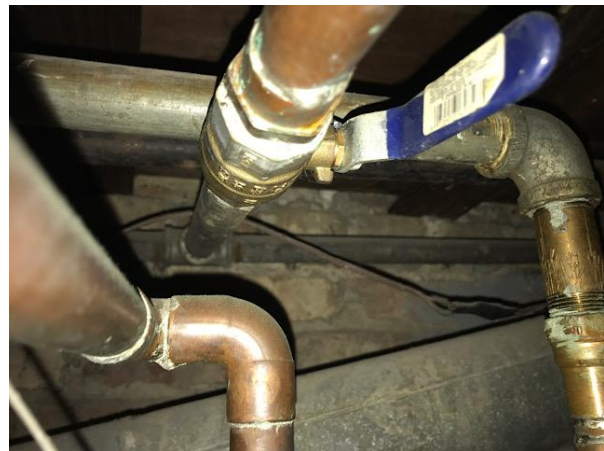
corrosion: missing dielectric union

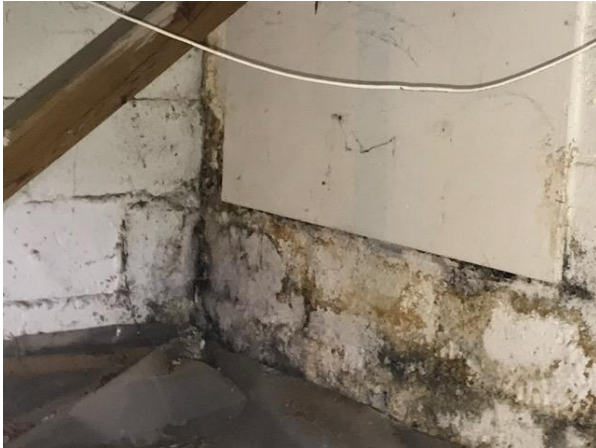
Seepage stains and organic growth

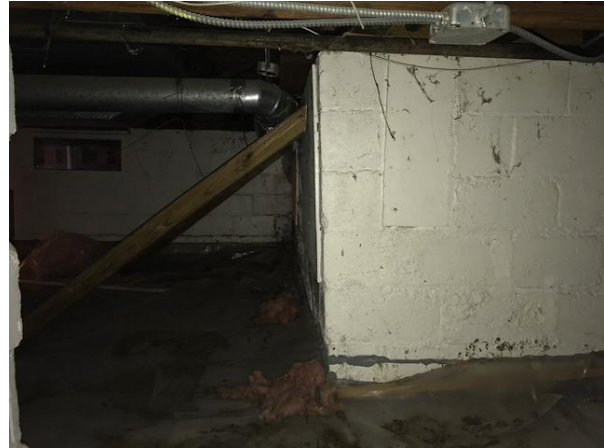
Leaning portion of north foundation block wall. Have evaluated by a structural engineer.

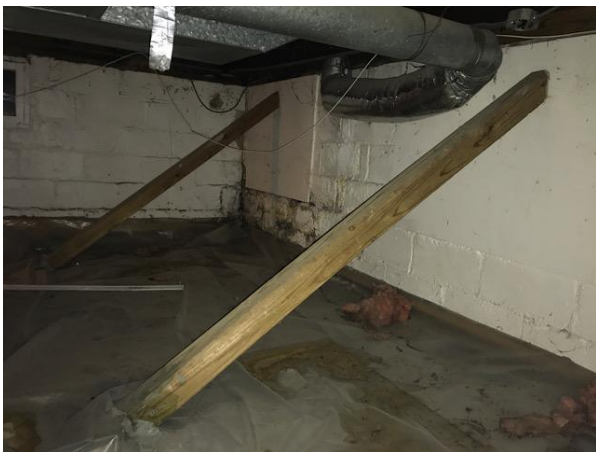
Poorly supported with 4x4 posts

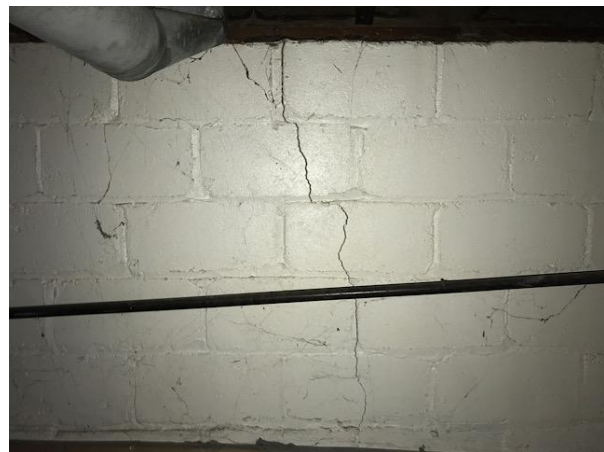
Cracks visible inside and outside.
