# Home Inspection Report

of  
326 W. Main St.  
Sample IL.

for  
Mr. and Mrs. Homebuyer  
on  
Monday, January 1st.

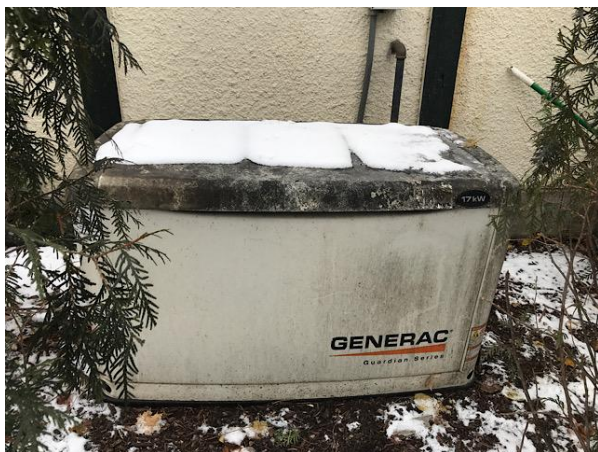
Generator. Requires annual service.

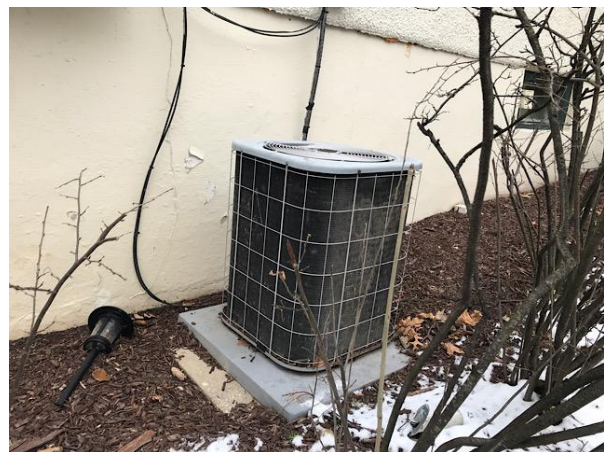
A/C East condenser

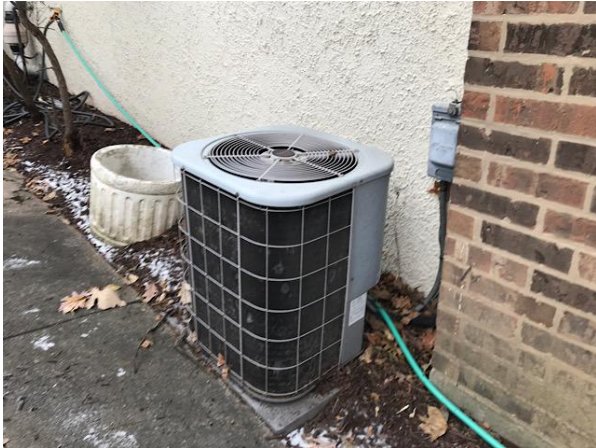
A/C West condenser

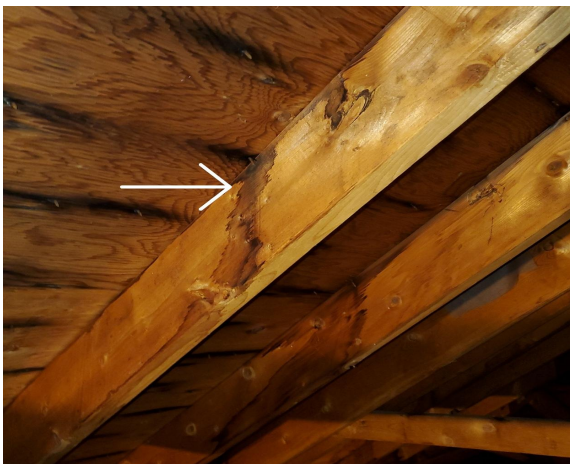
Darkened rafters

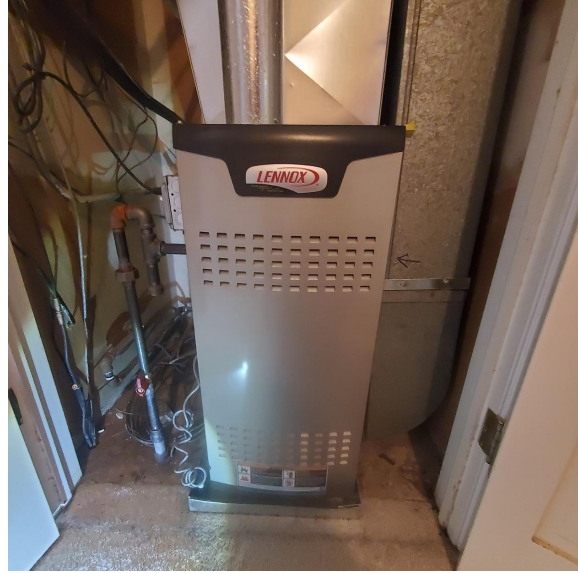
2nd floor 2021 Lennox furnace
